Demolition of the Fixed Service Structure FSS and Rotating Service Structure RSS, Launch Complex 39B at the John F. Kennedy Space Center, Florida.

**LIMITED ASBESTOS INSPECTION  
FOR THE  
DEMOLITION OF LAUNCH COMPLEX PAD 39B  
AT  
JOHN F. KENNEDY SPACE CENTER, FLORIDA**

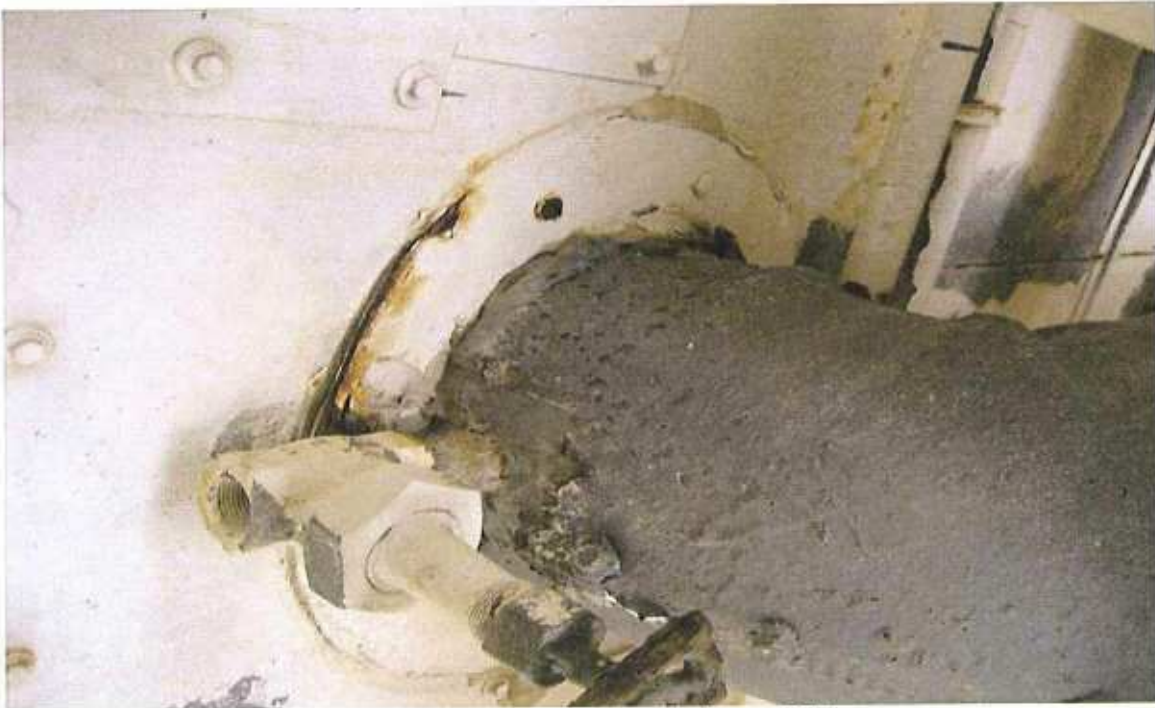
Photo 25 - Gray Pipe Insulation at RSS

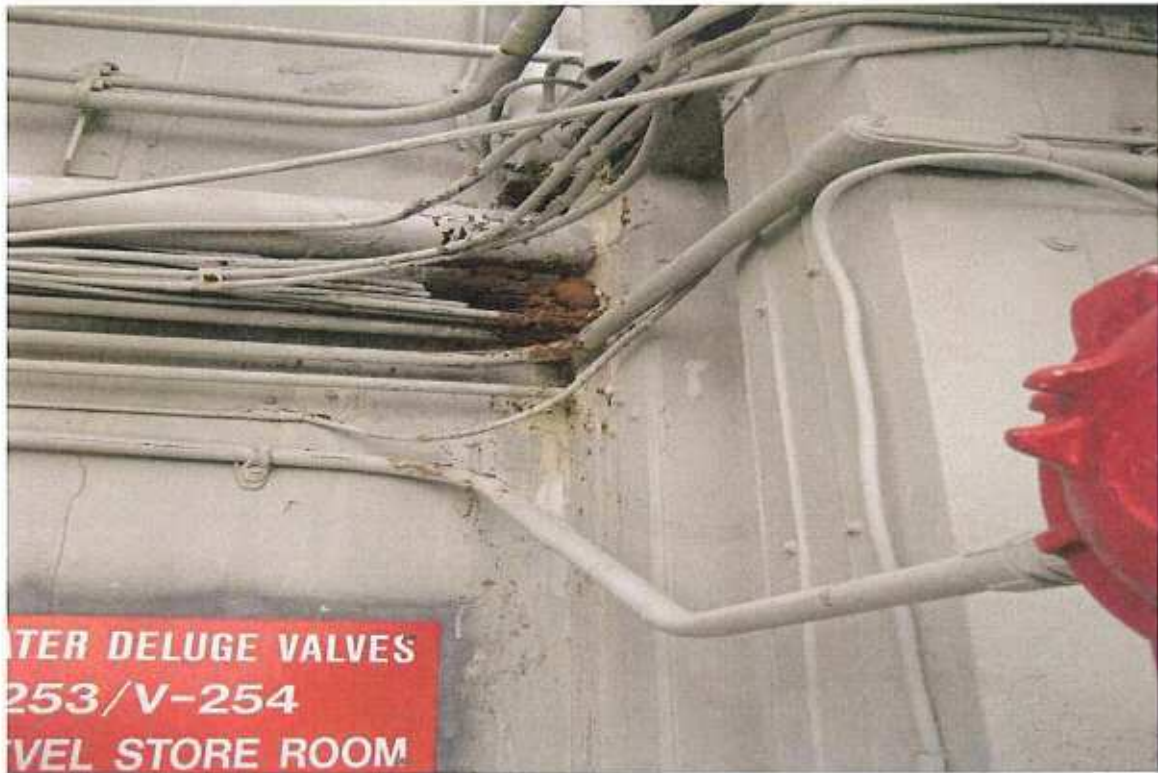
Photo 26 – Foam Insulation on RSS

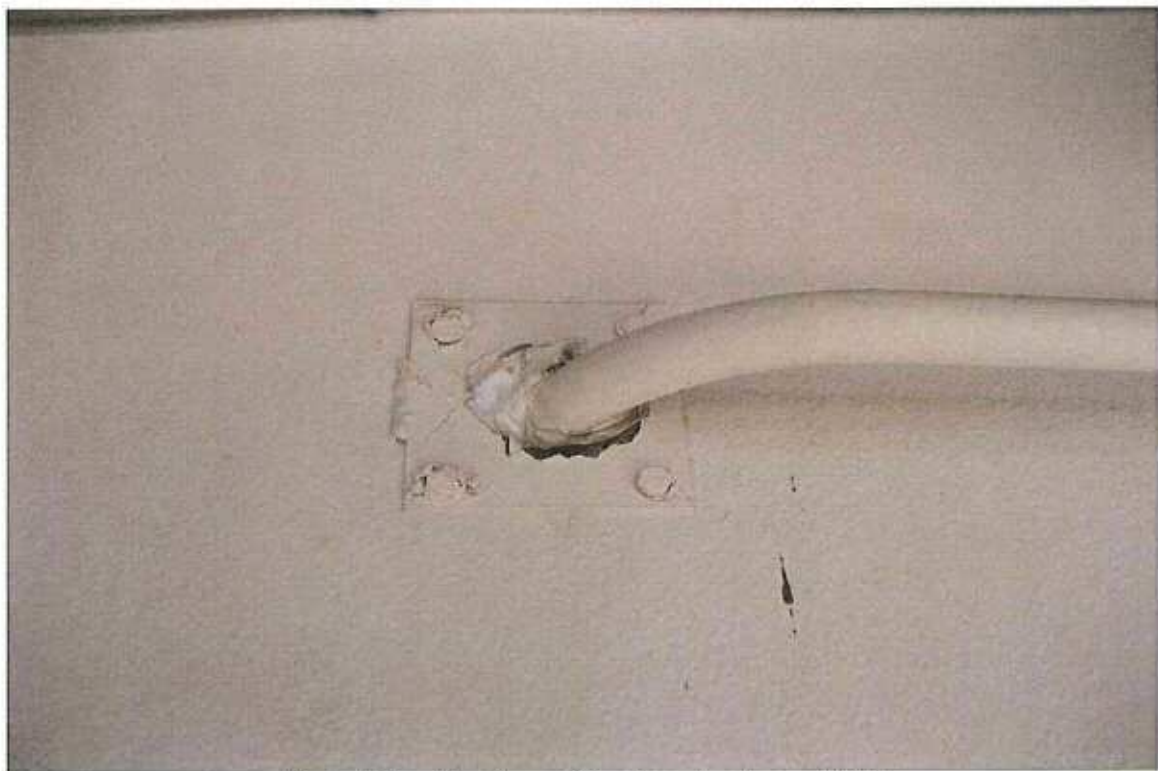
Photo 27 – Mastic on Pipe Penetration on RSS
